Client: Siemens Water

Project: 100,000 gpd WWTP in Pennsylvania

- **Identify Cause of Plant Effluent Failure**
- **Fix Operation**

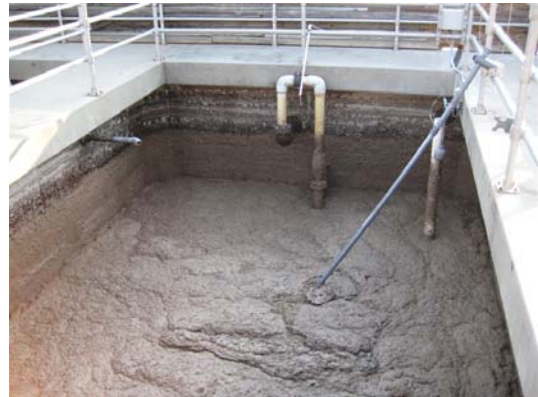
Examination of plant operating records revealed that the SBR effluent was reasonable, but the Effluent Disc Filter was ineffective. After much additional investigation the problem was clearly the very small size of biomass particles in the SBR effluent which then passed through the filter. The process conditions which caused this problem were identified as follows:

- a. The contract operator applied chronic and excessive chlorination to the SBR; this created a severely dispersed and limited microbial consortia with no flocculation.
- b. The over-chlorination predictably and dramatically reduced nitrification; the Operator responded with excessive over-aeration – causing further deflocculation.
- c. The Operator exacerbated these conditions by then operating at an excessive sludge age - running very low F:M to meet required nitrification with rates suppressed by over-chlorination.
- d. The Operator added a flocculent to improve disc filter operation – but added it to the SBR instead of to the SBR effluent only.

The Biological/Chemical causations of this failure were ultimately resolved, after much negotiation with the Contract Operators.
